August 24, 2006

RE: 1234 Any street NW
Anoka, MN 55303

Inspection Report

**1234 Anystreet NW
Anoka, MN 55303**

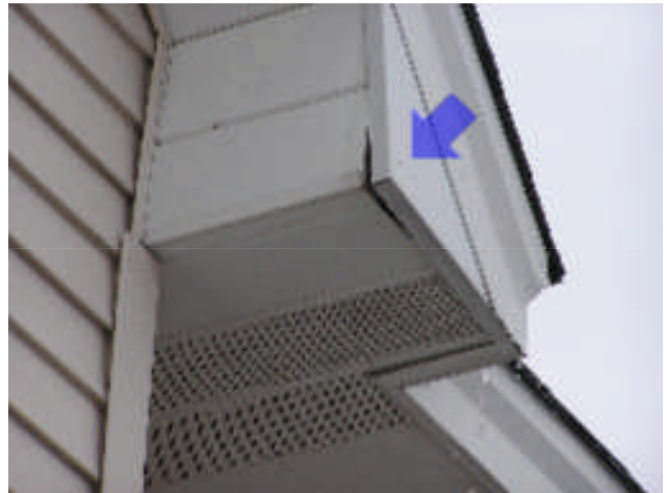
MATERIAL: Aluminum.
CONDITION: Loose material needs to be nailed to prevent moisture intrusion.

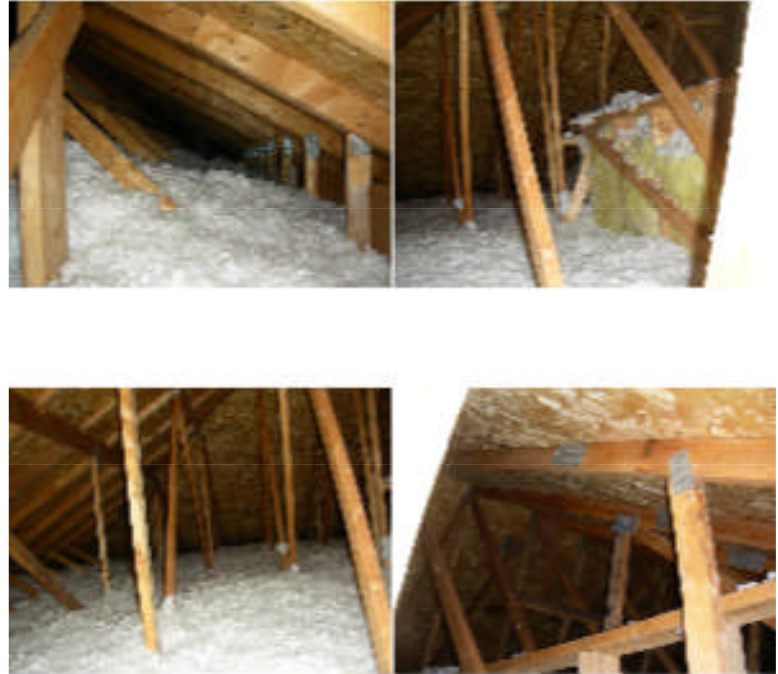
Fiberglass- Blown, Appears serviceable.

15 inches, R-44.

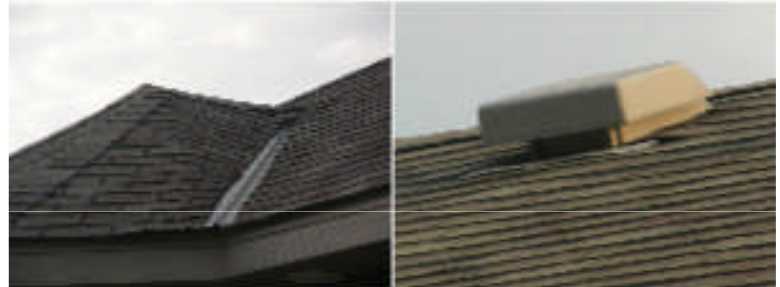
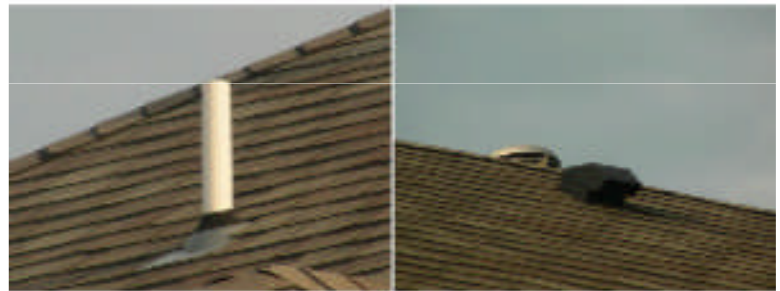
Appears serviceable/within useful life. 11 years old.

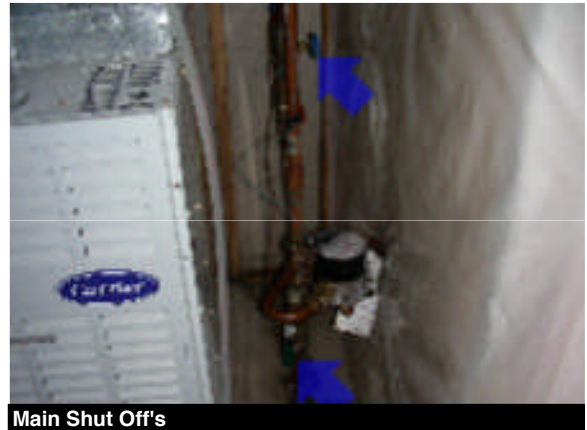
CONDITION: Appears serviceable, Water meter is located in utility room, Valve is operational, Main line is 3/4 inch diameter, Water pressure appears adequate.

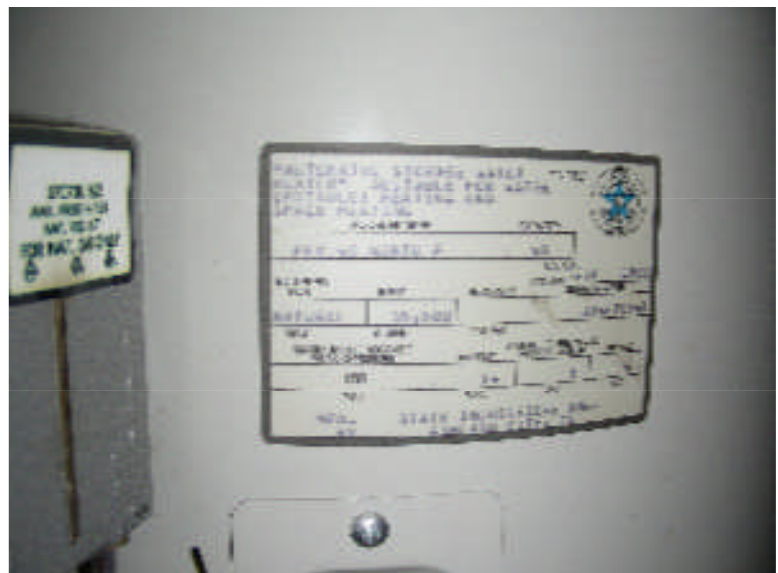
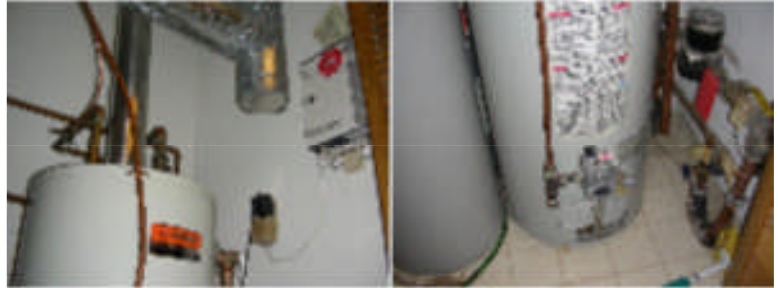
TYPE: Gas. Date of manufacture 1991

Appears serviceable, Pressure relief valve noted, not tested, Flue vent intact, A water shutoff valve is installed.

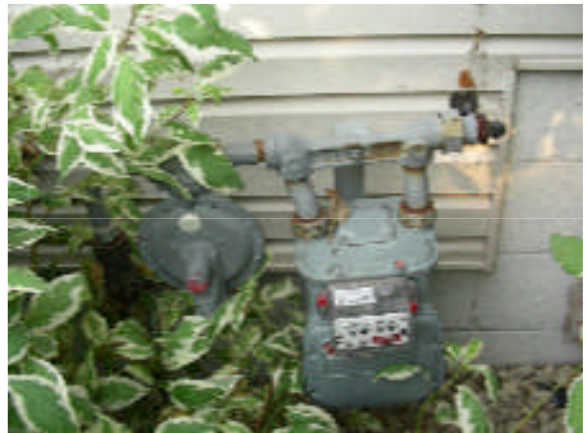
Meter located at east side of house, System appears serviceable.

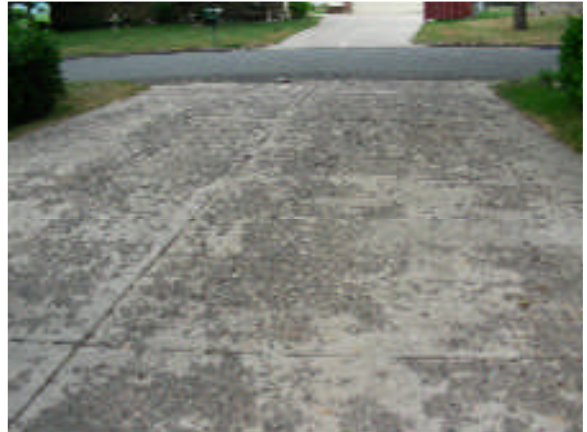
Appears serviceable, Cracks noted are typical. **Spalling noted:** This condition is generally caused by overworking surface when poured, or from overuse of salt to remove snow / ice. This condition is mainly cosmetic although, will shorten life expectancy of concrete.

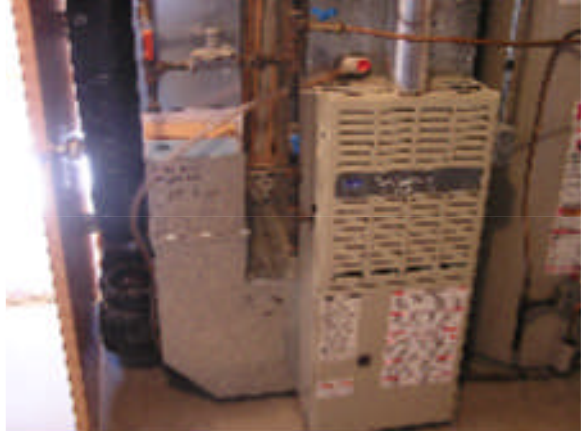
APPROXIMATE AGE IN YEARS: Date of manufacture: 2001

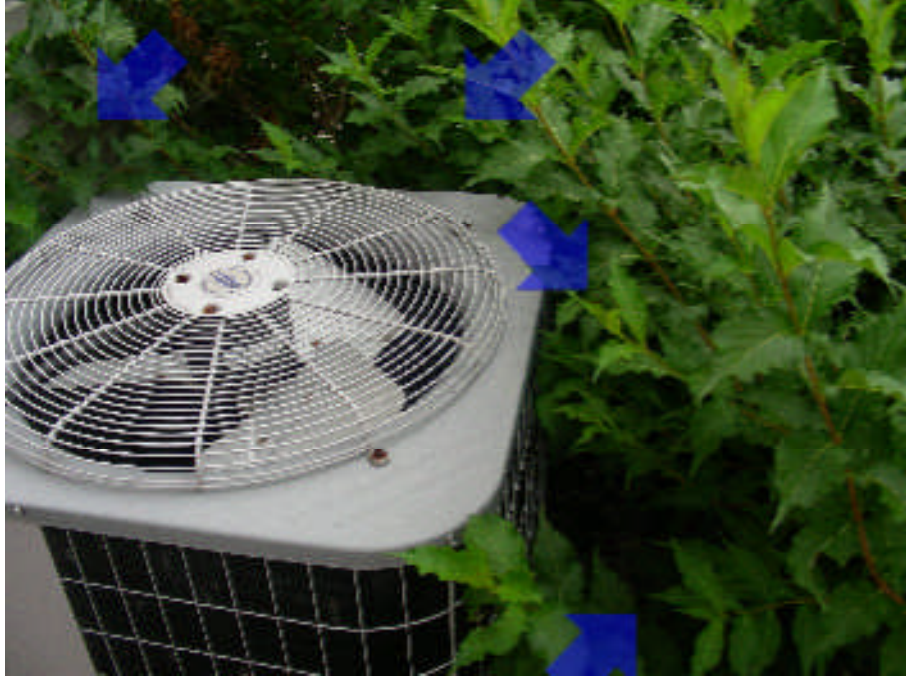
Central, Electric, Appears operational. [Recommend clearing foliage from unit.](#)

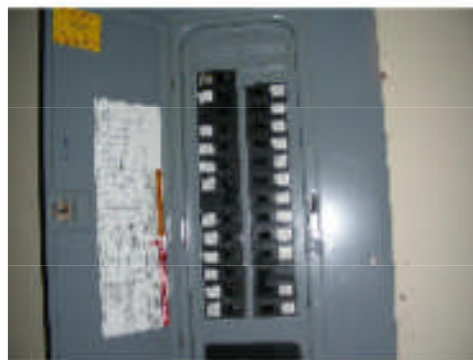
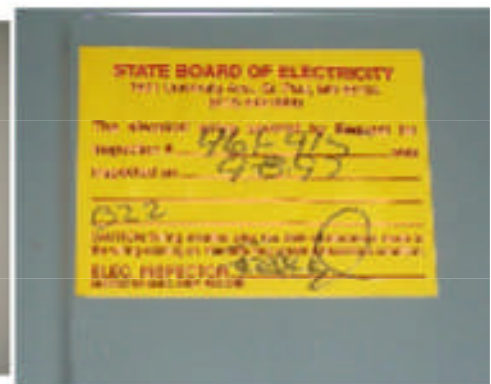
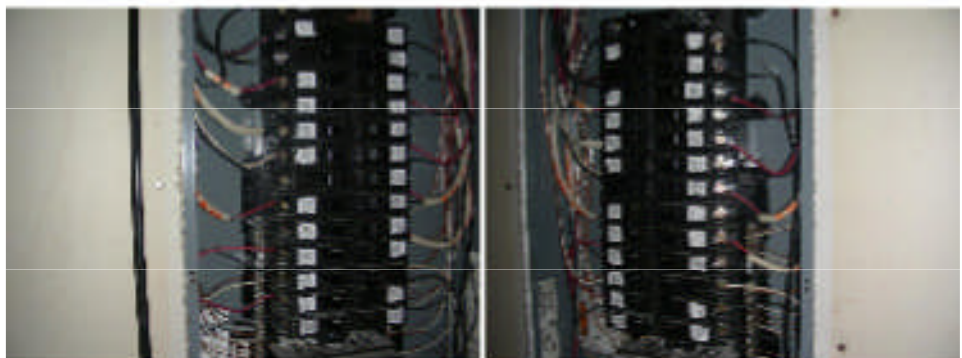
Appears serviceable. Basement, Utility Area.

Circuit and wire sizing correct so far as visible, Grounding system is present.

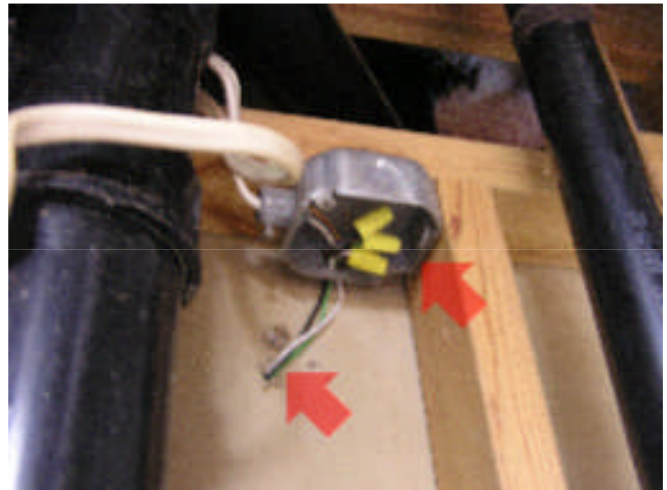
Copper, Appears serviceable. **Unsafe conditions exist, Open junction boxes are noted. Wiring to bathroom light not in conduit, box should be moved to wall position directly behind bathroom fixture.**

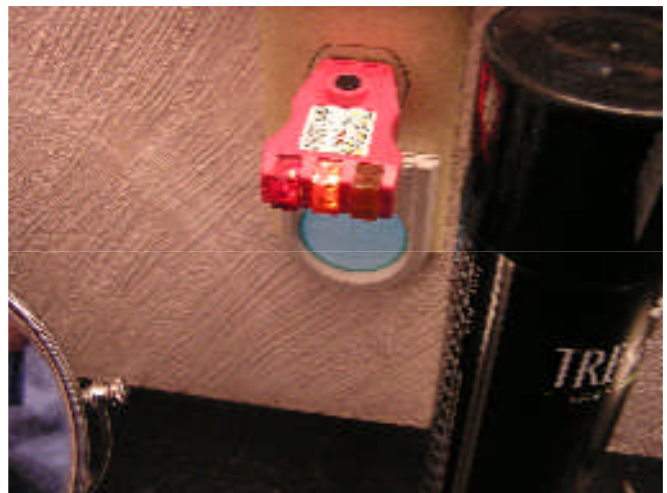
A representative sampling of switches and outlets was tested. As a whole, outlets and switches throughout the house are in serviceable condition. Stored items prevent access and testing at some outlets and switches. Ground Fault Circuit Interrupter (GFCI) outlets are recommended for installation at exterior, garage, bath rooms & kitchen outlets. **Reverse polarity is noted. Basement bathroom.**

Reversed polarity in an outlet is simply the improper connection of wires to the outlet itself, and is easily correctable. Because of the nature of this work however, I suggest you leave the repair to a licensed electrician. Some electronic appliances sustain damage when connected to reversed polarity outlets.

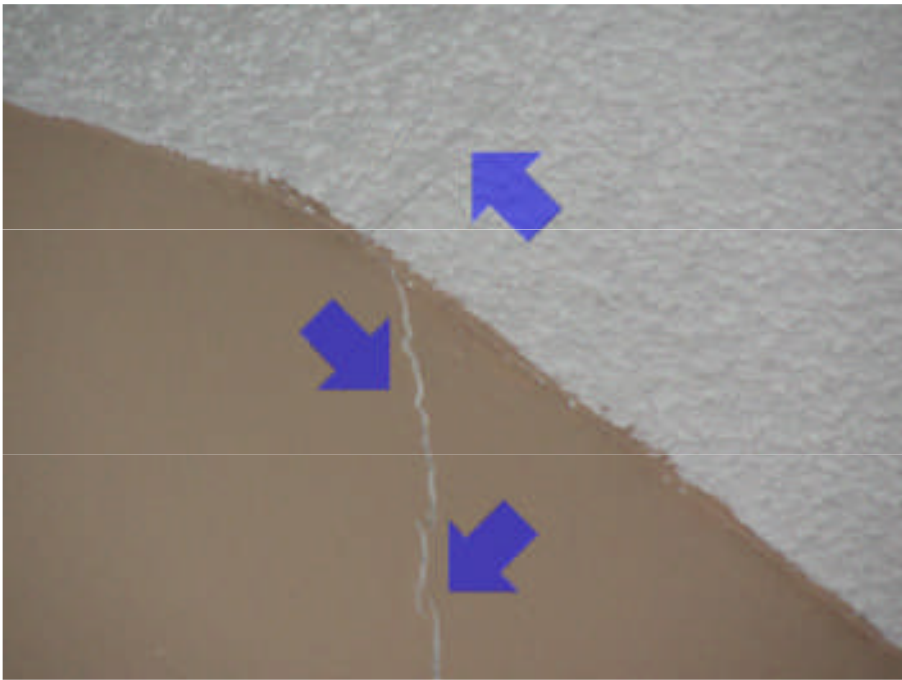
Drywall, General condition appears serviceable. Typical cracks noted: In vaulted ceiling, living room/ kitchen at peak. Expansion cracks at ceilings generally occur at seams between pieces of plasterboard. This is a common cosmetic deficiency which occurs most often at interior vaulted wall / ceilings. Singular cracks can often be repaired by using acrylic latex caulk, wiping off excess caulk as you go with a wet sponge, and then repainting. Often retaping with nylon mesh tape may be required, or even replacing the drywall so that joints will not lie on likely settlement areas.

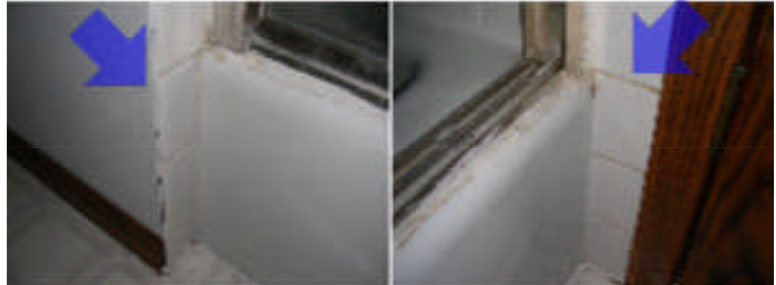
Cosmetic moisture damage is noted at the wall or floor outside the tub/shower area.

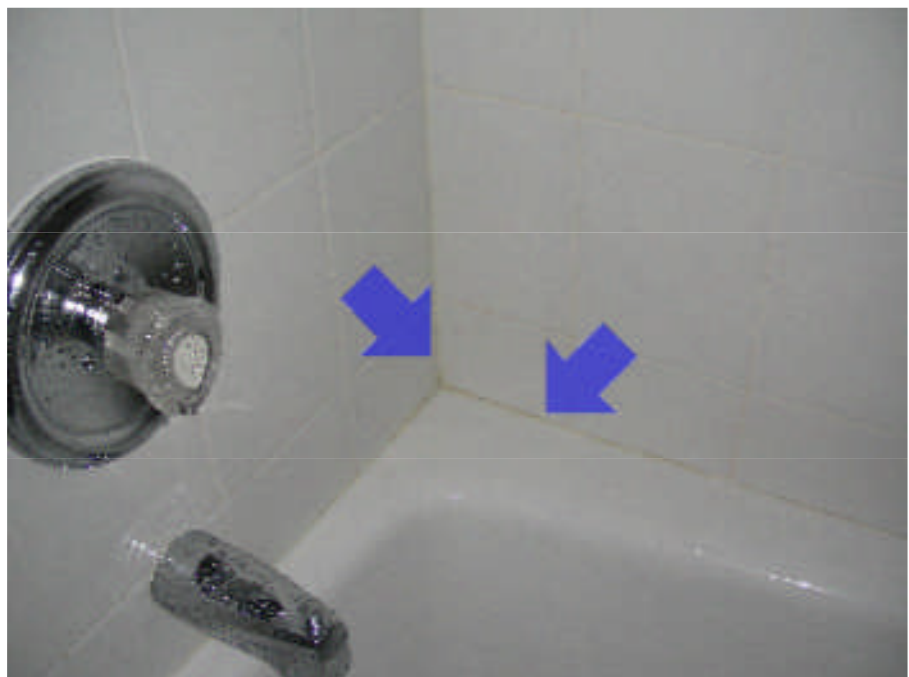
Tub and shower areas appear serviceable, Shower walls appear serviceable, Enclosure appears serviceable, Caulk and seal all tub and shower areas as a precaution.
